A RUDE AWAKENING

REPORT

of the
Judicial Flood Inquiry Tribunal²
on the causes of major breaches³ in River Indus
during the “exceptionally high floods” of 2010

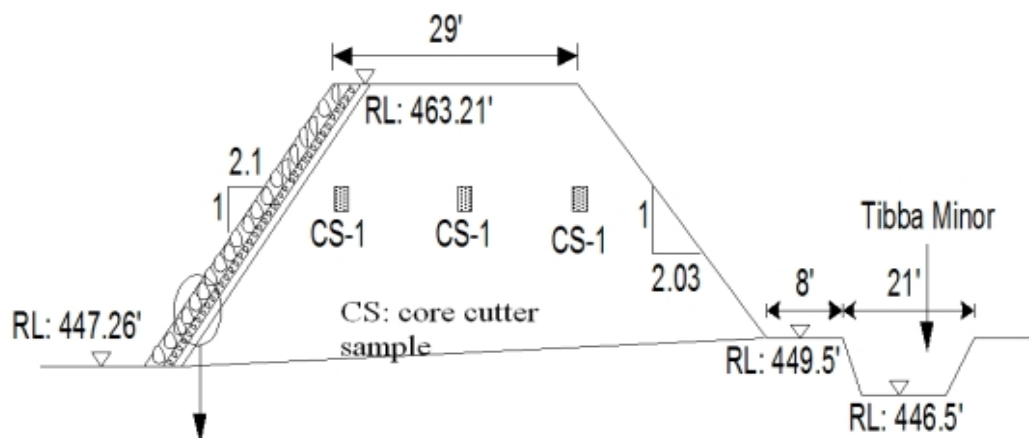
i. Figure 2 shows the cross section of LMB at the breached section. The x-section is drawn as per measurements made at the time of the visit. Three core cutter samples were procured from the face of the breached section (RD 33+000) in order to characterize the material of the bund. The samples were approximately taken from mid height, one sample from central portion, one from river side and one from the opposite side, the approximate location of the samples recovered is indicated in Figure 1. Plate-1 shows the view of the breached section at RD 34+000. It is worth mentioning here that an irrigation channel named as Tibba Minor is flowing in close proximity of the LMB at the breached portion as shown in Figure-1 and can also be seen in Plate-1. Plate-2 shows the close view of the face of breached section at RD 33+000 in which it can be observed that tree roots have penetrated in to the bank which might have contributed in seeping the water through the bank leading to initiation of piping process.

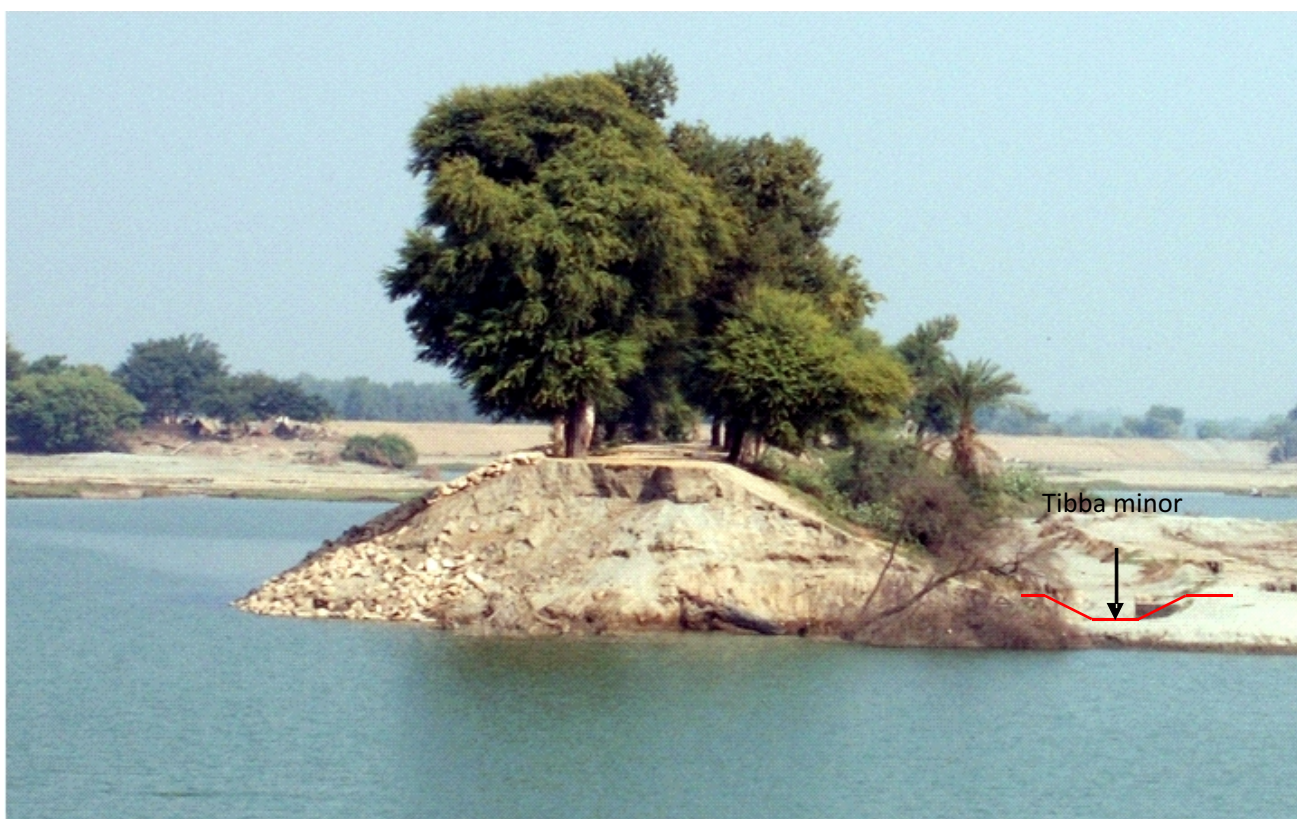
Photo showing view of face of pitched breached section (RD 34+000)

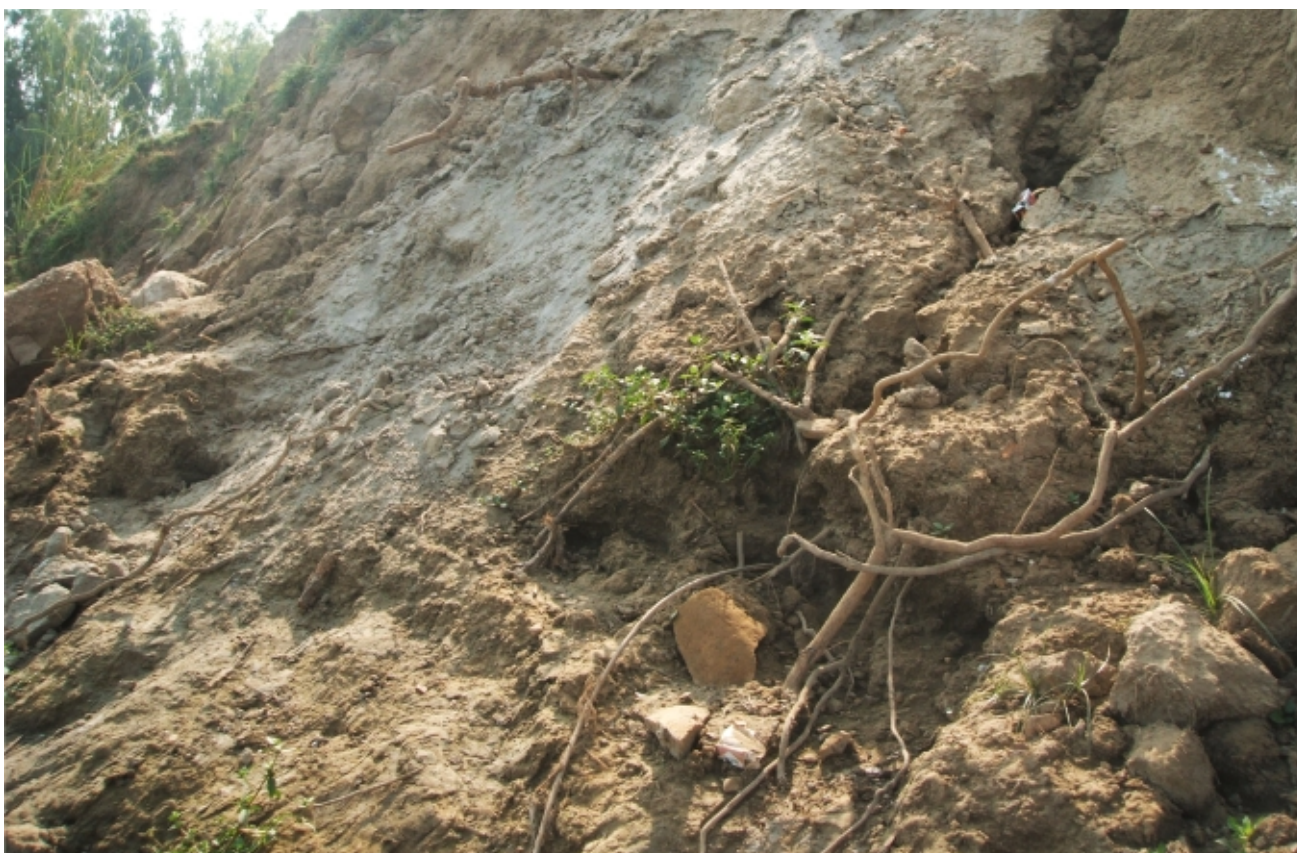
Closer view of face of pitched breached section at RD 33+000

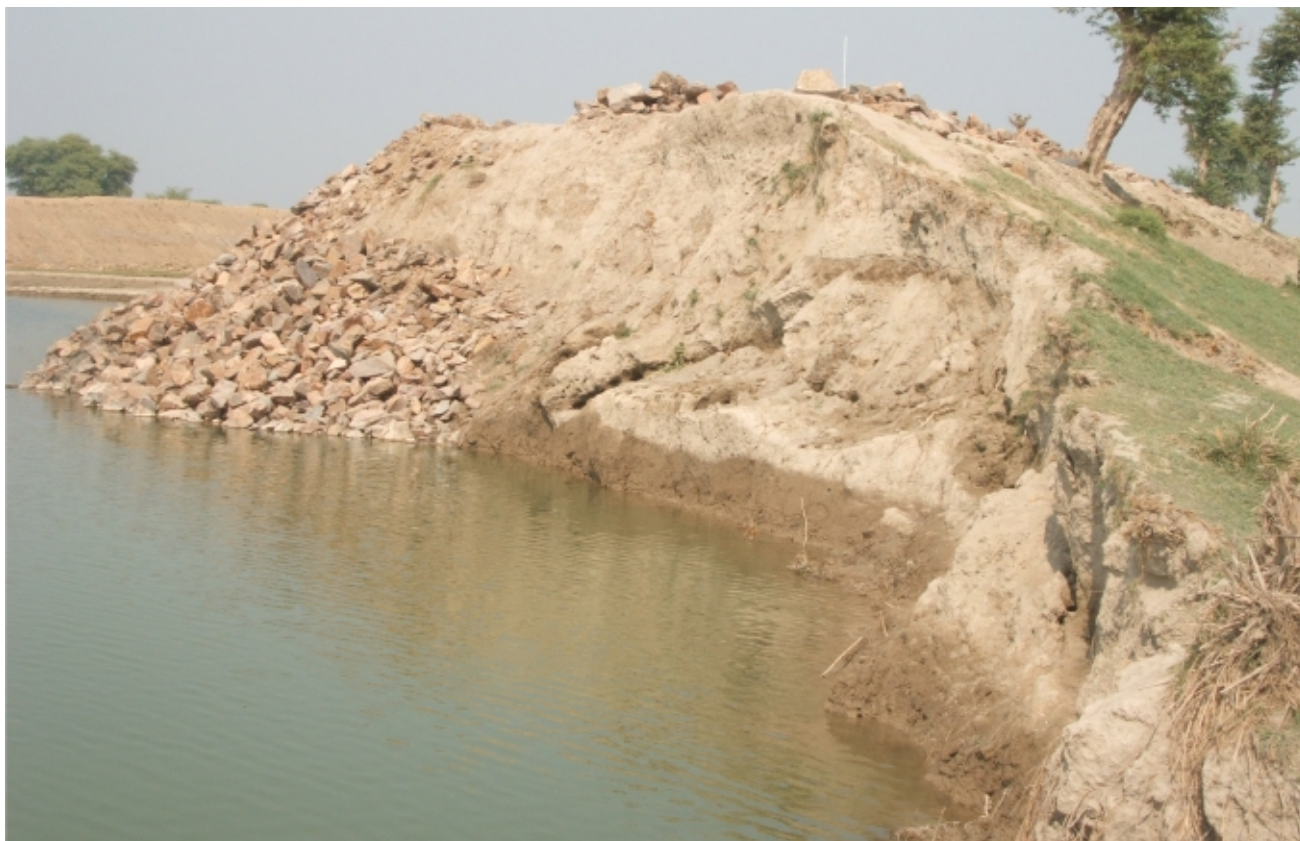
i. Figure 2 shows the cross section of LMB at RD 39+000 (Un-pitched portion). The side slope on the river side is 1V:2.1H, whereas the side slope of the opposite side is 1V:2H. The core cutter samples to determine the in-situ density of the bank material were procured at the locations shown in the Figure 2. Plate-4 shows the photograph of the breached section.

Photo showing face of un-pitched breach section at RD 39+000

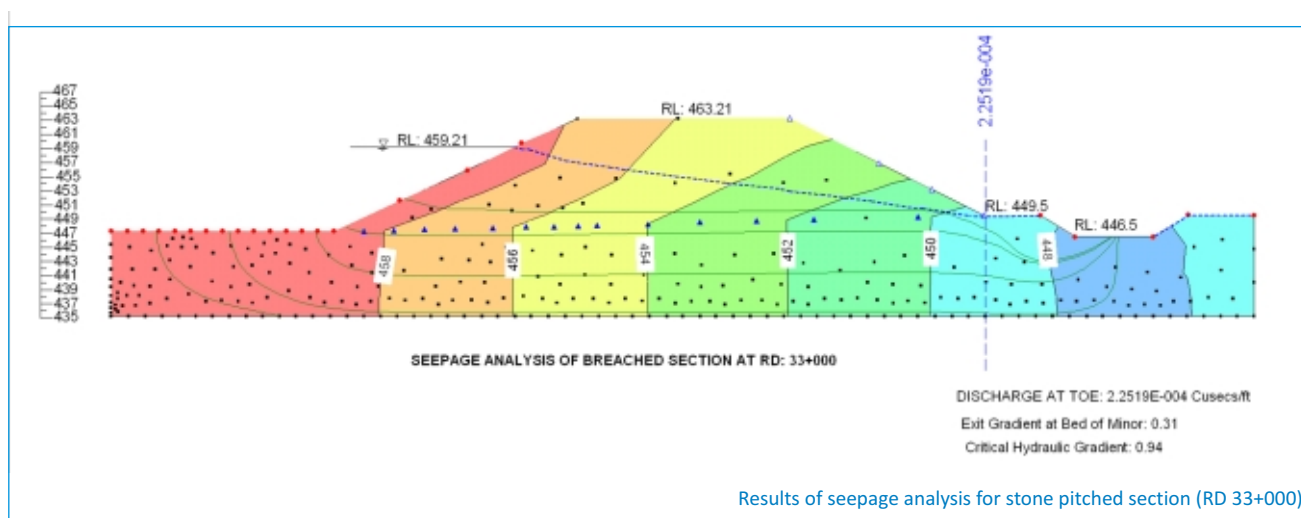
iii. The results of the seepage analysis indicate the probability of piping action to be started in the bed of the Tibba minor. This has also been confirmed by the Engineer (Ch. Afzal, SDO Taunsa Barrage) on duty at the time of the breach that sand boiling was observed in the bed of the Tibba minor few minutes before the actual breach started.

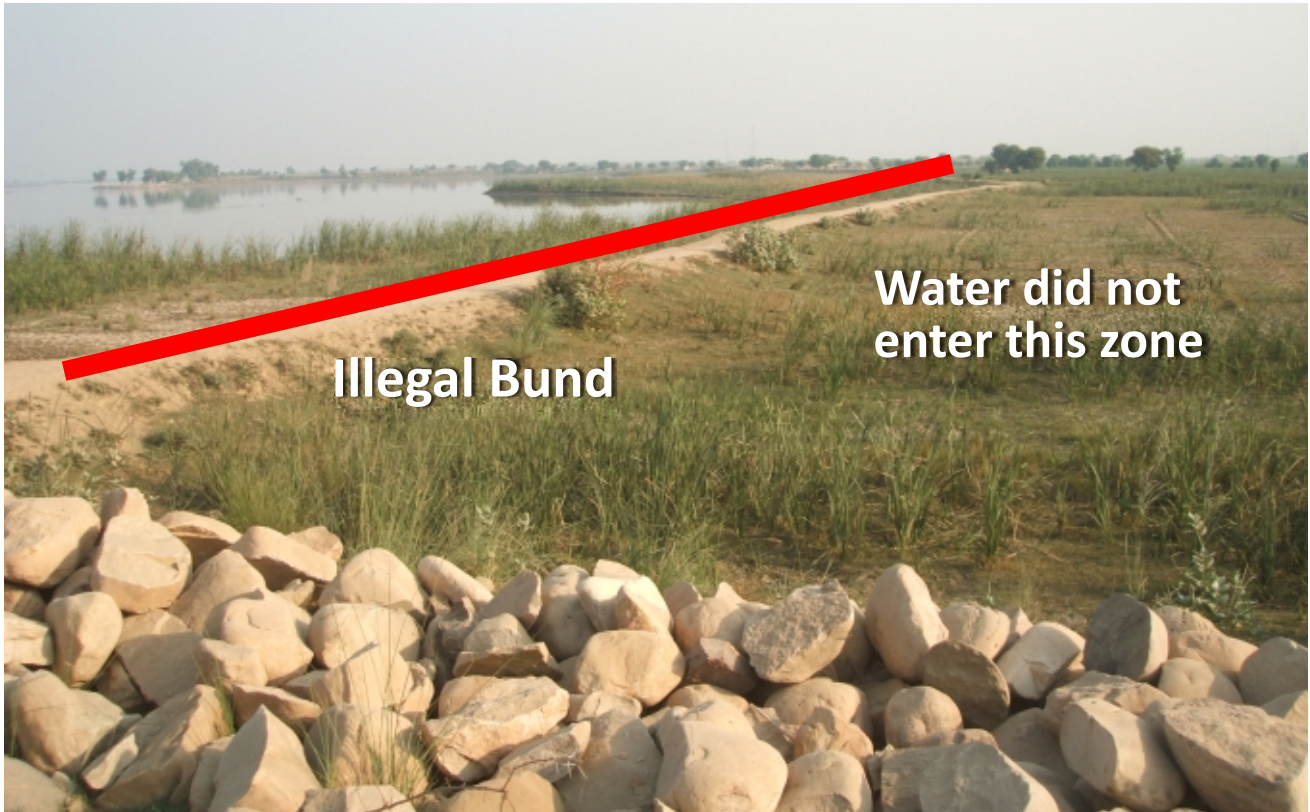
Photo showing presence of illegal bund between Spur # 1-A and T head Spur-5

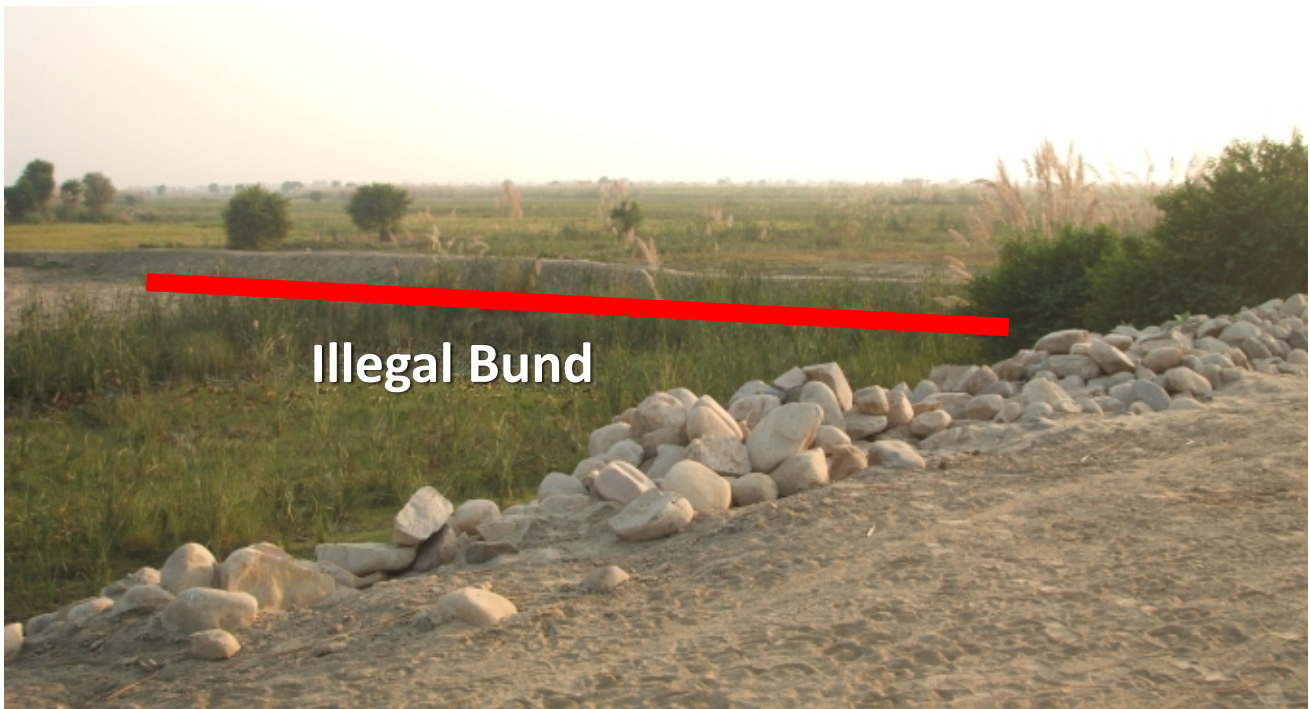
Photo showing presence of illegal bund between Spur # 1-A and Spur # 2-A

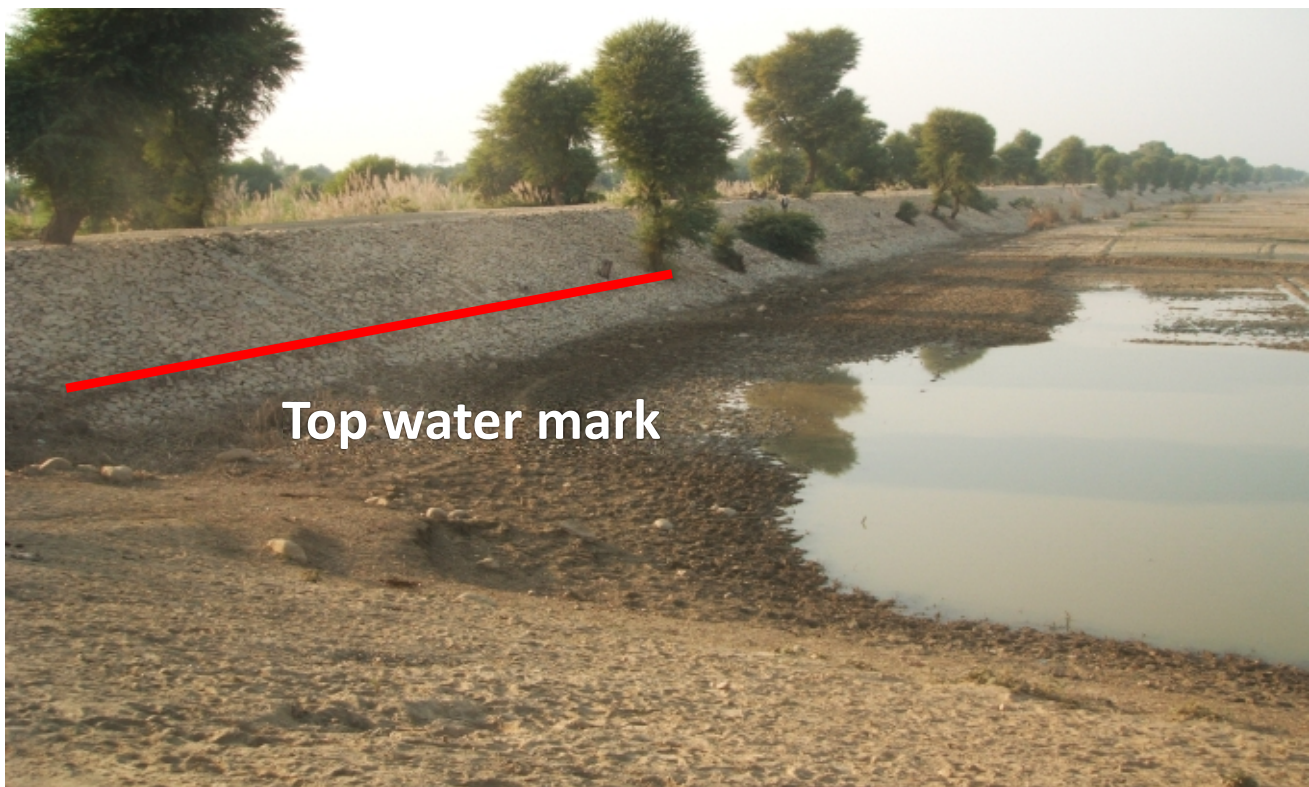
Photo showing presence of flood water in area between Spur # 2-A and Shank of Spur # 2 and water mark on the bank

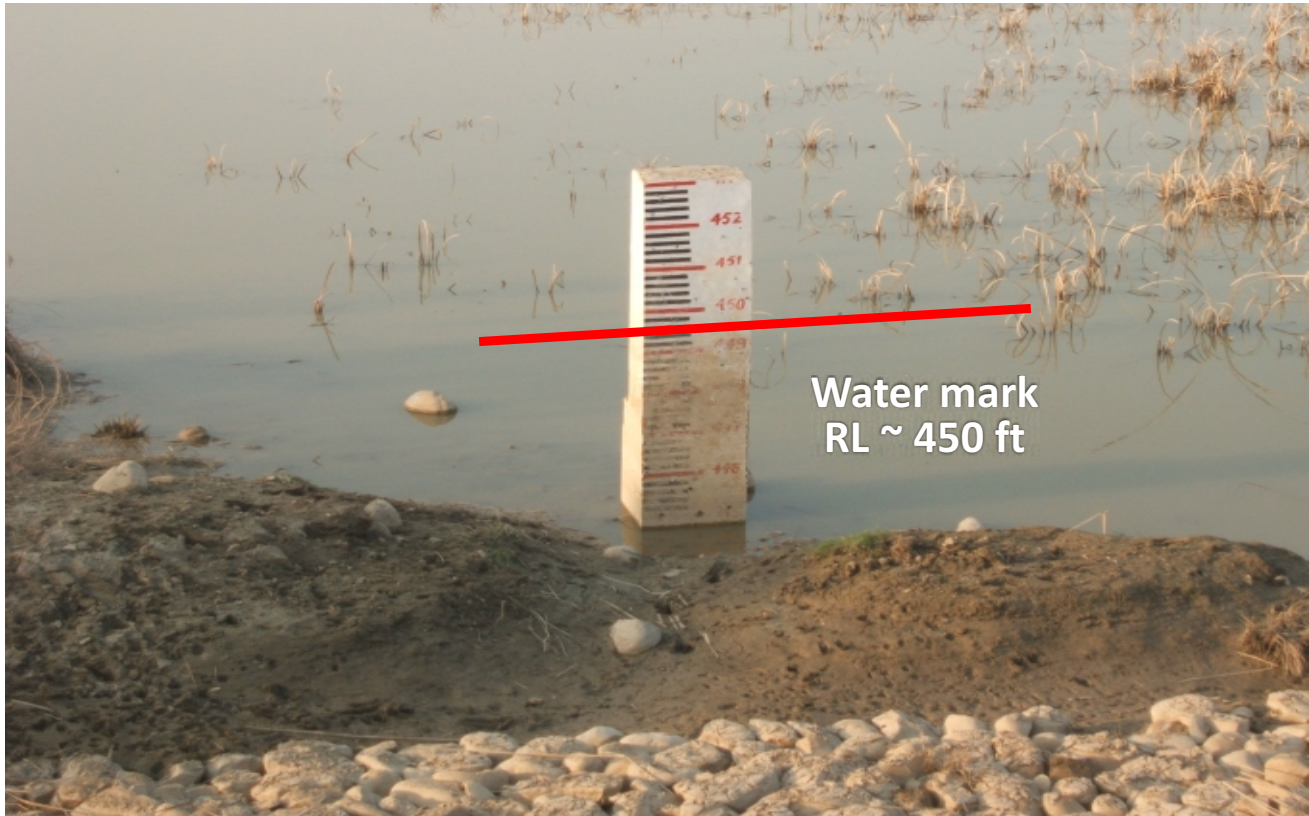
Photo showing water mark on a gauge area between Spur # 2-A and Shank of Spur # 2
